Coroners Inquest

**917 Dundas Street W,
Whitby**

2016 OMFPOA Symposium

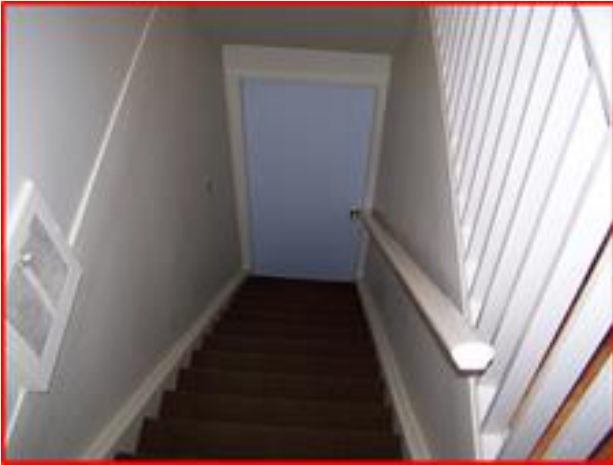
Stairs leading from the 2nd floor unit

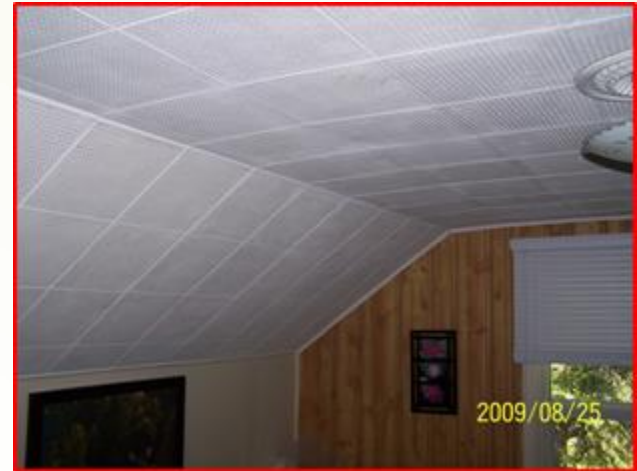
Upstairs dropped ceiling and paneling

- Upon re inspection, Inspection Order must be complied with, or 1 of the 5 elements must be permanently removed
- Notes and photos must be taken showing the completed work
- If the unit contains a drop ceiling or wood paneling, these items must be completely removed to verify the existence of drywall
- WFES has revised the SOG to reflect these new changes
- An video is being created with the cooperation of the family to be used as an educational tool for teenagers (hard to reach audience)

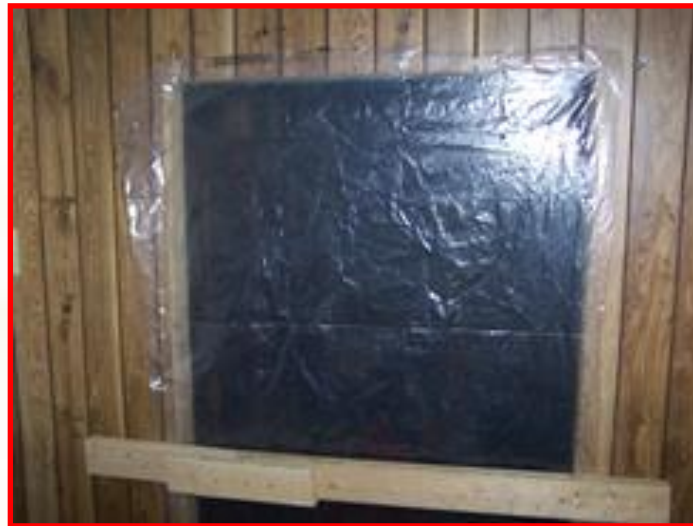
Breezeway paneling
